EU EDF 8/9 – SOPAC Project Report 53  
Reducing Vulnerability of Pacific ACP States

## TECHNICAL REPORT ANALYSIS OF COASTAL CHANGE AND EROSION – TEBUNGINAKO VILLAGE, ABAIANG, KIRIBATI

March 2006

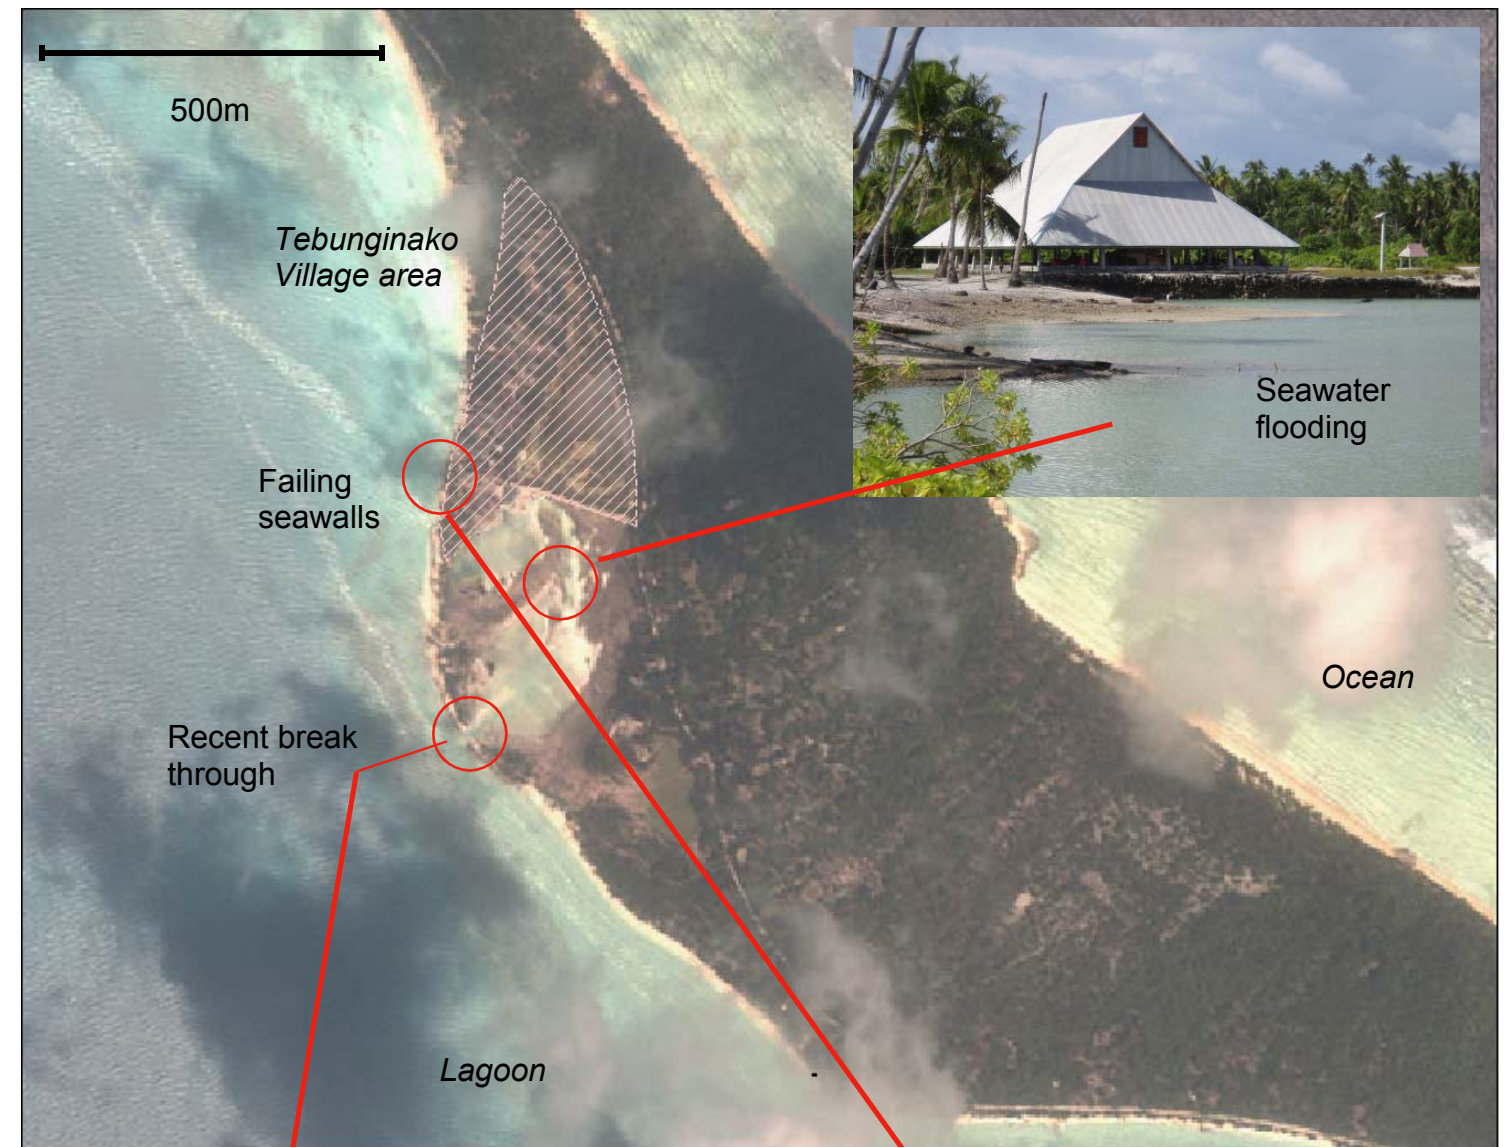
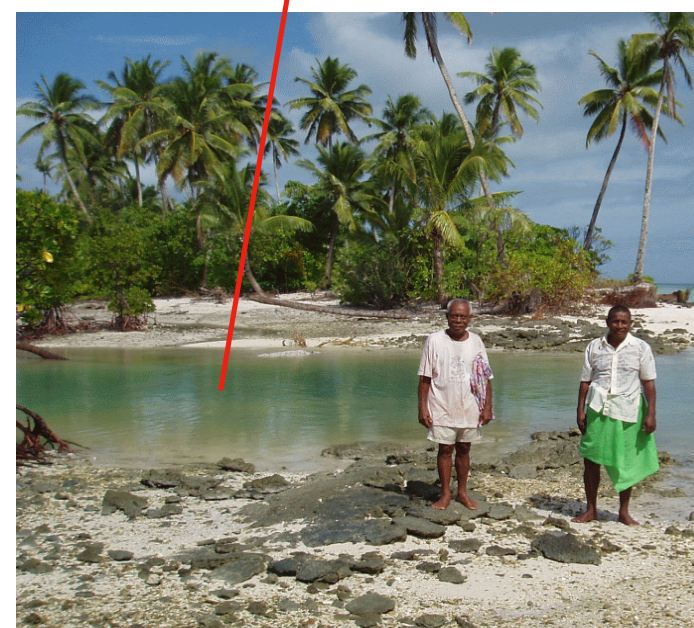
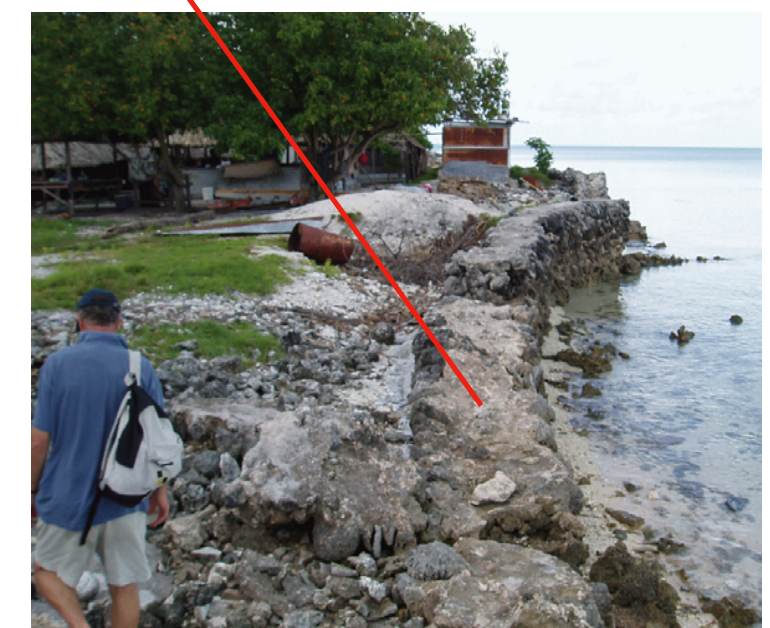
*The 2004 satellite image close up of the Tebunginako Village area and a summary of the issues presently faced by the village. Seawall failure, erosion of the sand bank and subsequent break through of lagoon waters into a formerly freshwater pond. Also, nuisance seawater flooding on the village boundary.*

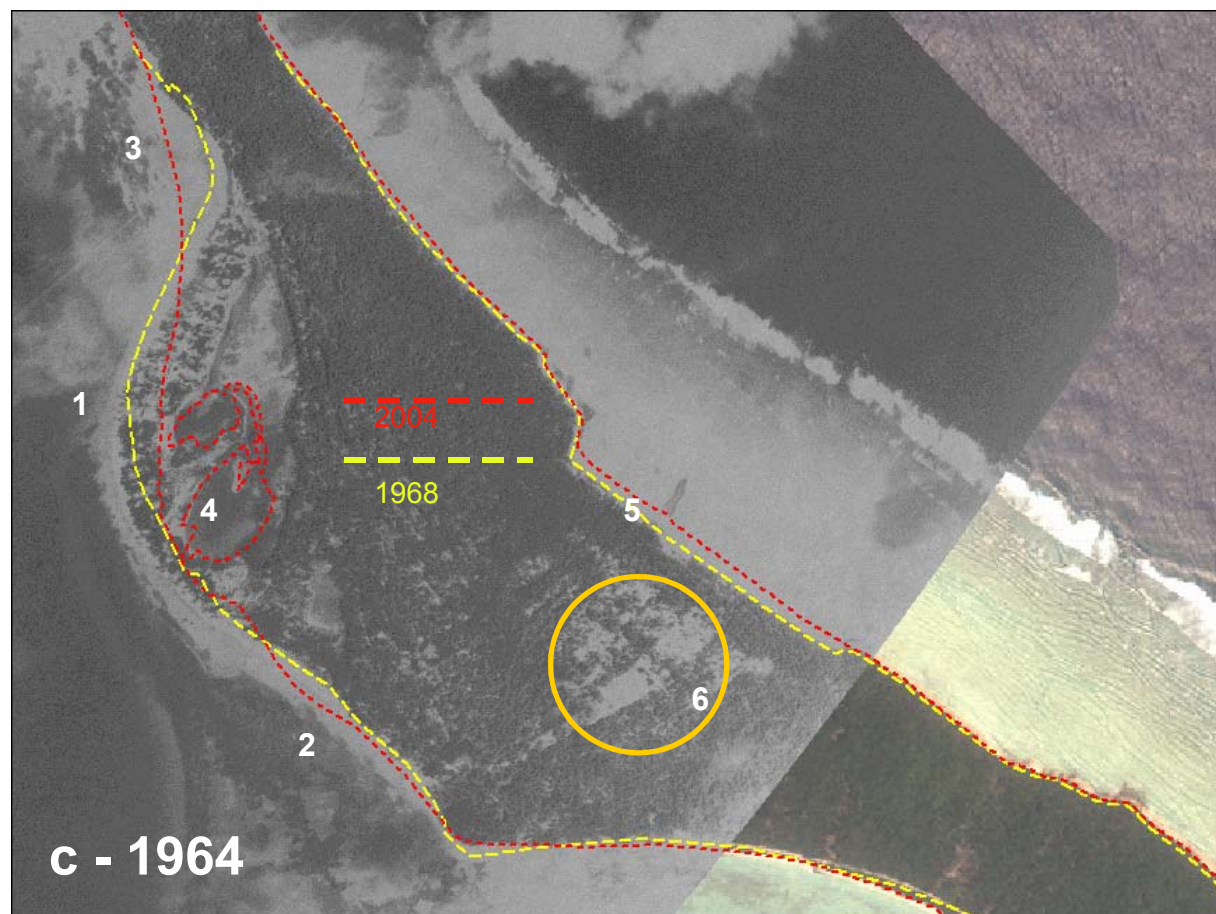
**Historical coastline changes (multi-temporal comparisons)**

These figures show a comparison of the Tebunginako Village area in 2004 (a), 1968 (b) and 1964 (c). The superimposed shorelines shows the large degree of shoreline change particularly on the lagoon coast (note all images are of identical scale and orientation and the black and white historical aerial photo boundaries can be seen where they over lay the base satellite colour image).

In 2004 (a) the position of the 1964 (red) and 1968 (yellow) coastlines show that approximately 2.73 Ha (6.7 acres) of land has been lost in area (1). However about 2.56 Ha (6.3 acres) of land has also accreted (built up) in areas 2 and 3. This shows that whilst there has been erosion at some locations (e.g. 1) the sediments are being redeposited in other locations. At location 3 the shoreline has accreted by nearly 100 m since 1964, overall there has only been a net loss of 0.165 Ha (0.41 acres) of land over the last 40 years.

Of particular concern to the village community however, has been the recent break through of lagoon waters into the freshwater ponds south of the village (4). In this area the shoreline has eroded about 50 m since 1964.

The historical aerial photographs (b and c) show some additional important information which gave clues as to what processes have been at work in this area during the last 100 years or so. Location 5 shows that a section (about 650 m long) of the ocean-side coast has also prograded (moved out) by some 20 m since the 1960's. The area in 6 (orange circle) shows a persistent feature in the vegetation of this area. Note the poor / sparse vegetation (whitish area) and the persistent curving boundary to the south of this feature. This is thought to be a prograding shoreline of the now in-filled channel and similar line features (running approximately parallel) can be detected over much of Tebunginako.

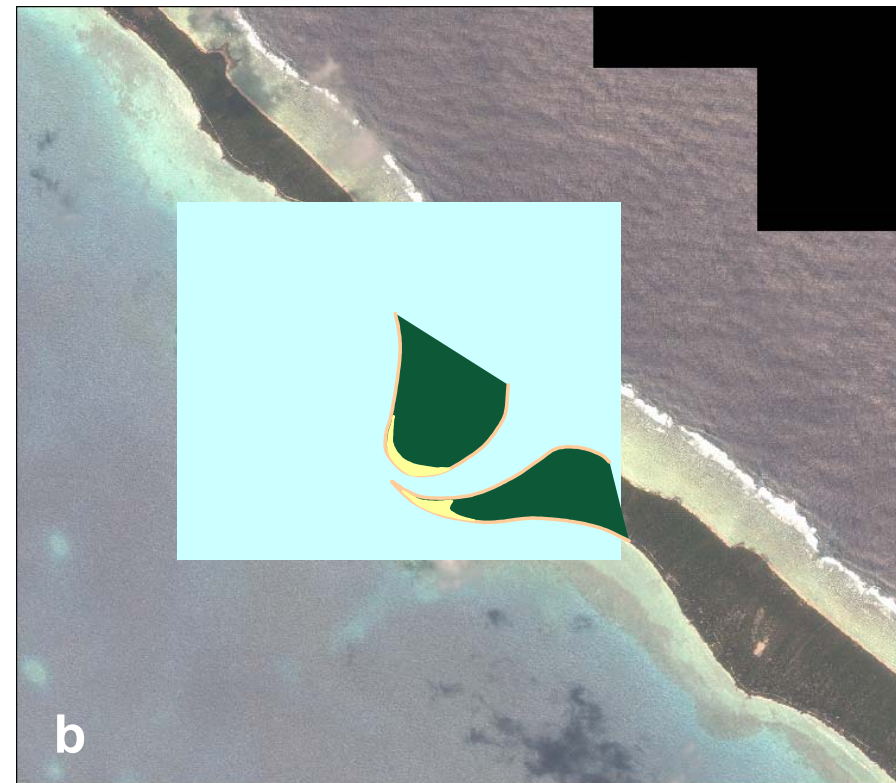
(b) Over time the channel fills with sand and eventually becomes narrower and shallower. The persistent northern sand transport pattern not only supplies this sand from the ocean reef through the passage but on the lagoon side it pushes a sand spit extending to the north.

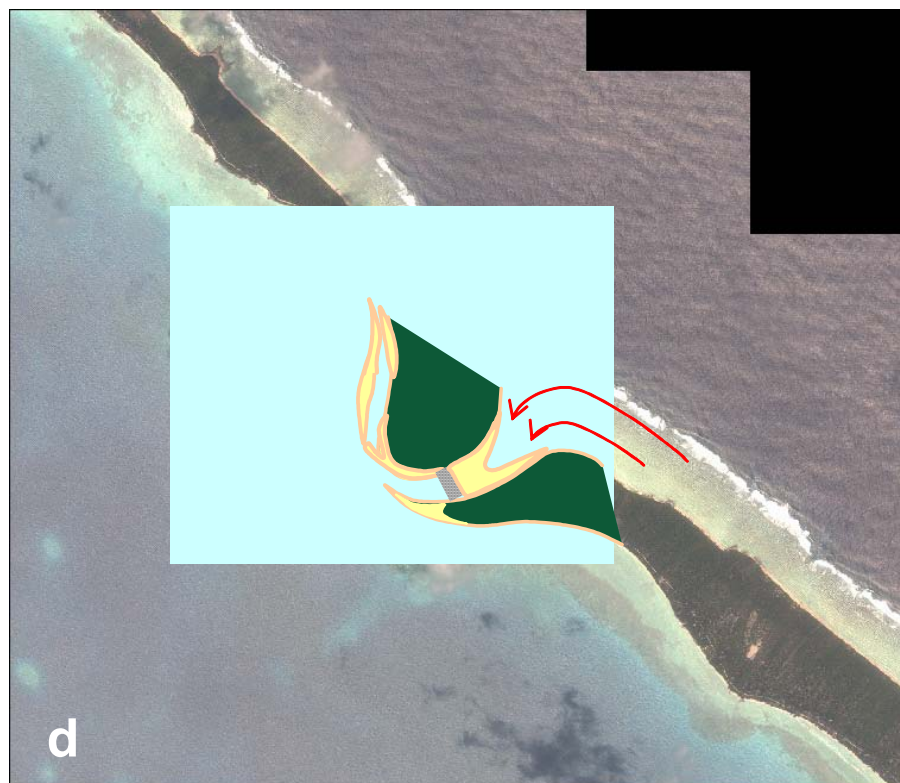
(d) At some time, about 70 to 100 years ago, villagers built a causeway across this channel (this area is still known as “*Terawabono*” – “the blocked channel”). This stopped the supply of sand moving to the lagoon side.

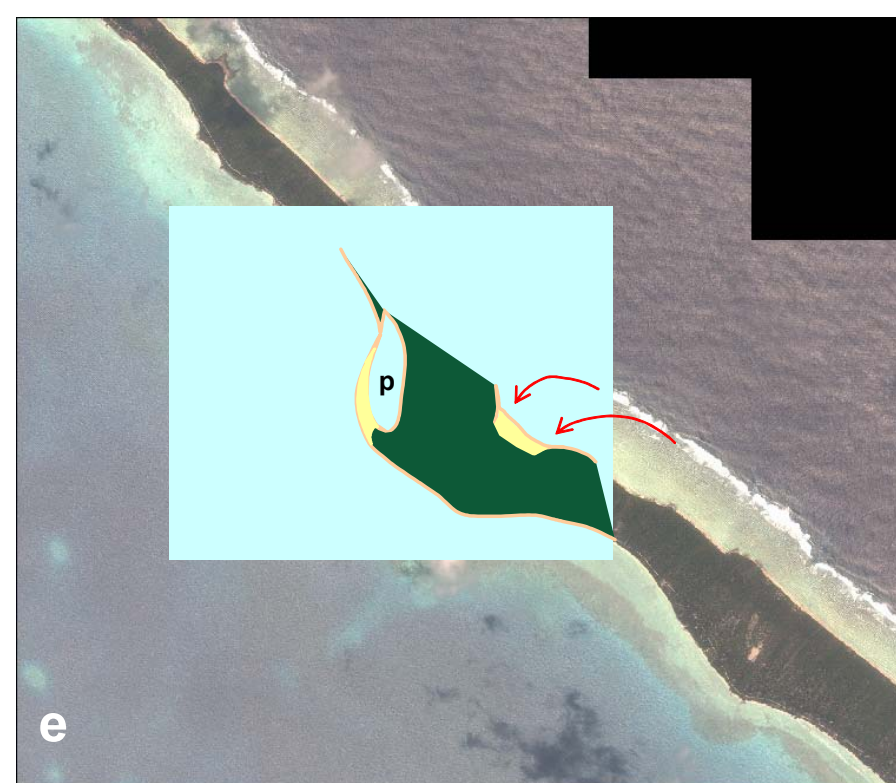
(e) With sand supply blocked the channel on the ocean side quickly in-filled (red arrows). On the lagoon side the unstable sandy spit moves and changes shape since the supply of sand from the ocean has stopped. Low areas which were once part of the lagoon / channel are isolated from the sea and over time become freshwater ponds (p).

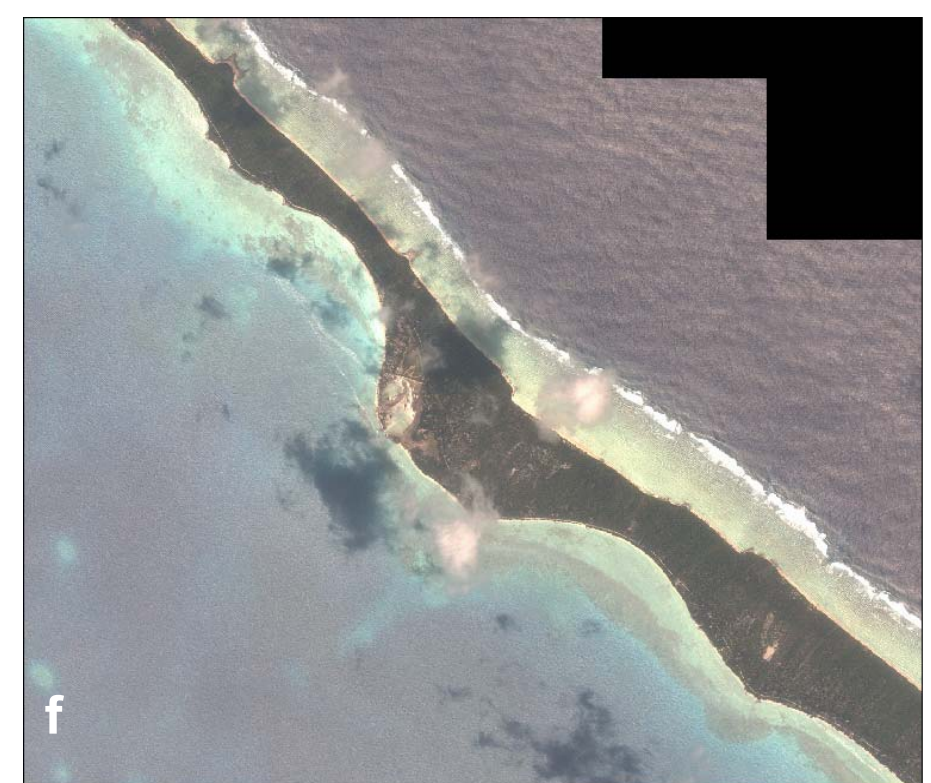
(f) Today, many people now live on this new land; however, the Tebunginako coastline is still moving and is unstable. The sand bank between the freshwater ponds and the lagoon has eroded to a thin strip and lagoon waves have now broken through, flooding settled areas with seawater.

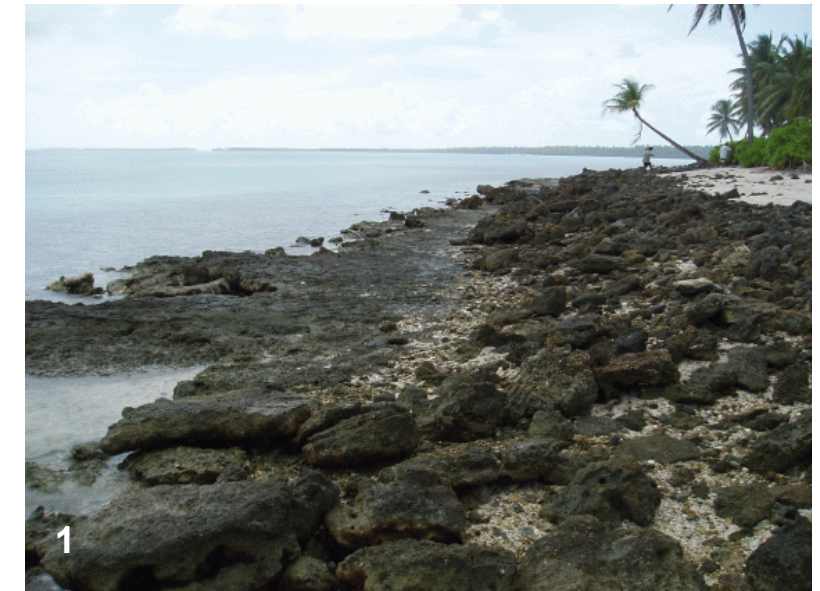
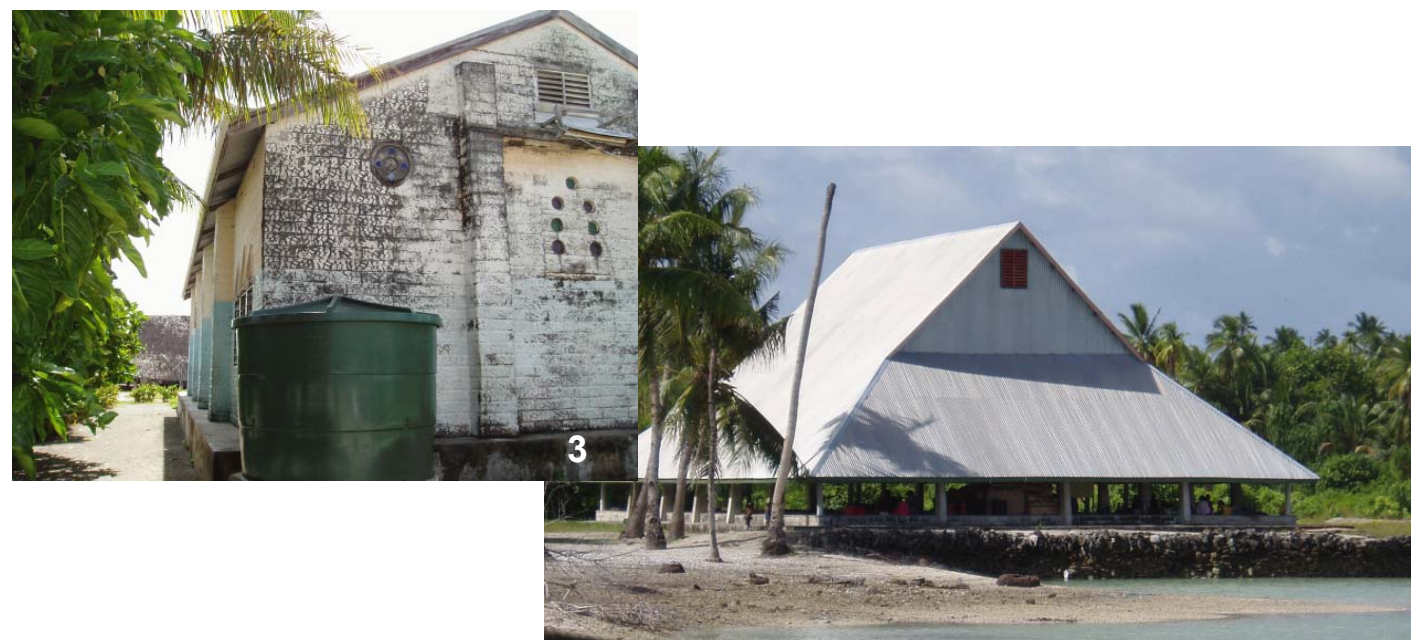
**Recommendations**

The people of Tebunginako have settled in areas which are unstable and the shoreline will continue to change over time for many years to come. Over the last 30 years the people of this village have spent a huge amount of time, energy and money trying to stop the natural movement of the lagoon shoreline. This has failed and much of the protective structures built have been destroyed by ongoing shoreline change and westerly gales (1).

In past times, people lived in harmony with shifting coastlines and their local buildings could be easily moved if the shoreline changed (2). Many of the houses in Tebunginako are still local but some large and important buildings (the village maneaba and church) are built of permanent materials and can not be easily moved (3).

During discussions with the people of Tebunginako Village it was agreed that the changes on their coast were caused by the blocking of the channel many years ago and that this coast would remain unstable for many years to come. It was also agreed that it would be better to use their time, effort and money to rebuild important buildings east of the road on high safe ground (4) and not to try and rebuild seawalls. It was understood that there was no need to move the whole village right way. In some areas accretion is occurring (the land is getting bigger) and so long as local houses are built in these areas, they could always be moved if need be. Certainly, permanent buildings should not be built anywhere west of the road and people in flooded areas should also be encouraged to move east of the roadway (4).
